Tomar, H., Parihar, V., Assi, A., Solanki, A., Parihar, M., & Shekhawat, S. (2022). Aesthetic rehabilitation of Ellis class III fracture: A case report. *International Journal of Health Sciences*, 6(S3), 3126–3131. <https://doi.org/10.53730/ijhs.v6nS3.6310>

## **Aesthetic rehabilitation of Ellis class III fracture: A case report**

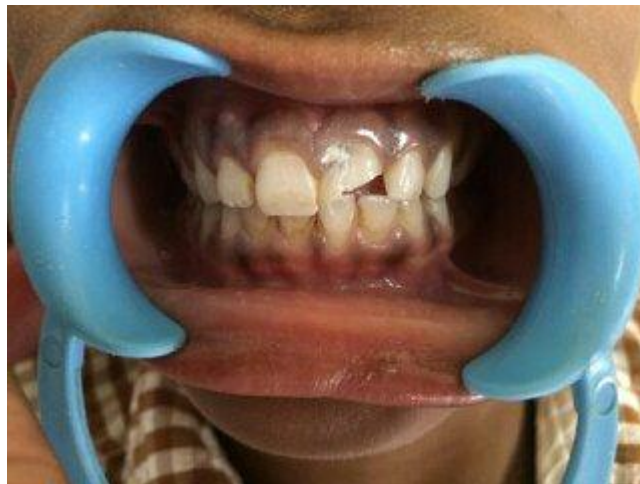
A 17-year-old male patient reported in my private clinic with a chief complaint of broken upper front tooth. Patient revealed in the history that he had an minor accident and had a blow on upper jaw resulting in fractured maxillary left central incisor (21) 3 days ago.[fig.1]. Intraoral examination revealed that the maxillary right lateral incisor was fractured. No associated root fracture was seen in IOPA radiograph. The alveolar bone and the periapical tissues appeared normal. A diagnosis of complicated crown fracture (involving the pulp chamber) – Ellis Class III w.r.t 21 was made. Noticing the severity of fracture and patient's pain, a decision of single-visit endodontic treatment was taken.

Figure 1. preoperative photograph with fracture irt 21

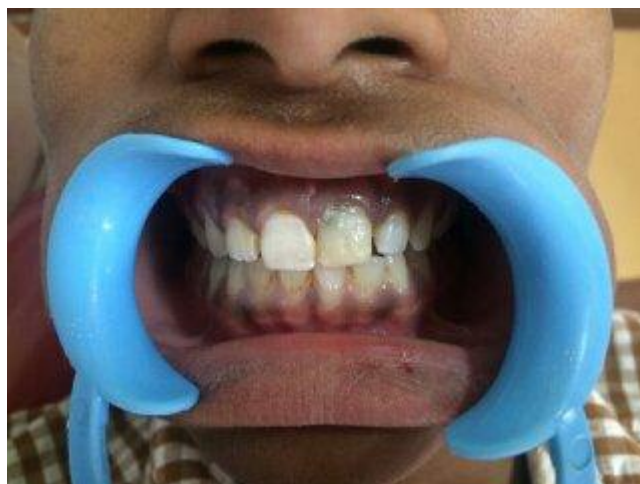
Figure 2. Composite build up following the root canal treatment

To fully evaluate the case a visual assessment was performed and the patient's occlusion was analysed. Shade matching was done and B2 shade was selected for the case. After getting proper isolation on tooth, it was thoroughly cleaned and scrubbed. The surface was etched for 40 seconds. Tooth was washed and dried using air-water syringe. The bonding agent was then applied to the prepared surface and light cured for 20 seconds. A thin layer of composite not more than 1mm in thickness was placed on the right central incisor which covers from facial to lingual preparation. Once the composite placement process was done in accurate and precise position the material was cured for 40 seconds on each surface. Similarly 4 more layers of composite were applied and cured stepwise to give the patient an aesthetic view up till next visit. [fig. 2]

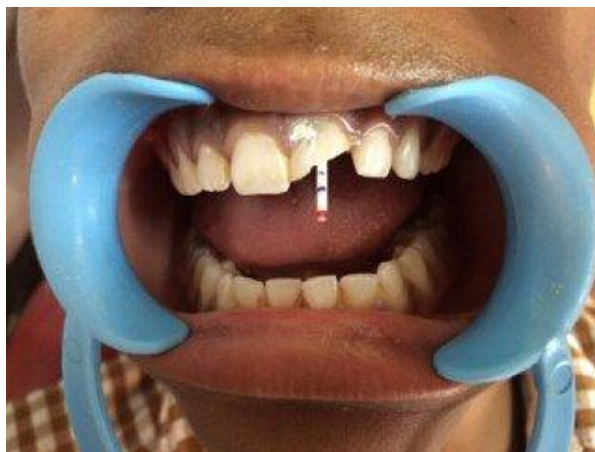
Figure 3. Fibre post placement

About 10mm of gutta percha was removed using gates glidden bur. Following that the pulpal wall of root was etched with 37% phosphoric acid (3M ESPE; Scotchbond™) and then bonded with dual-cure resin (3M ESPE; Rely X™ U200, Germany) under visible light. The occlusal clearance was evaluated and post instructions were given. The patient was recalled after a week. The tooth was prepared for full coverage crown (PFM). The crown was cemented after 2 days using glass ionomer luting cement (3M ESPE; Ketac™ Cem Radiopaque, Germany). [fig. 3,4,5]

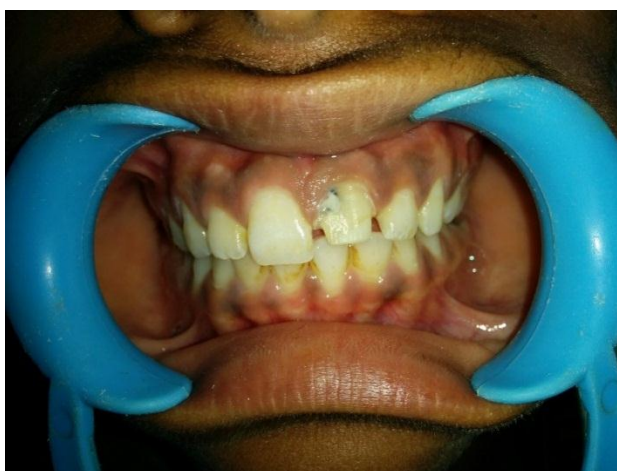
Figure 4. Tooth preparation irt 21

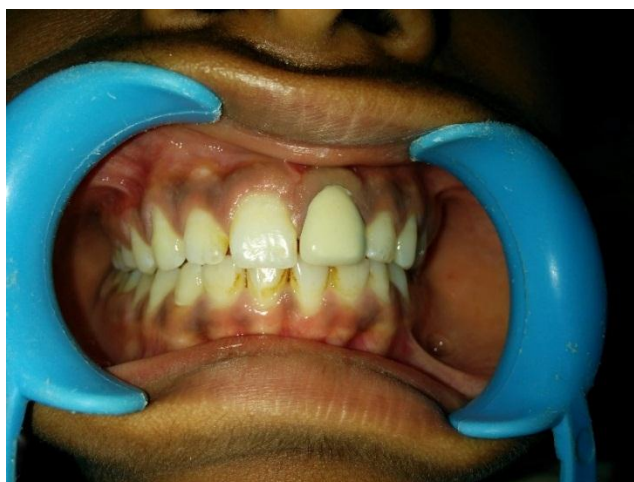
Figure 5. PFM crown cemented
